Sample Report

Customer	Schindler India Pvt.Ltd Chakan midc Phase II Pune	Measuring Site: Mr. Amol Shirguppe Chakan midc Phase II Pune Measuring Date: 1/11/2014
-----------------	---	---

Task	Paint Both Gate Leakage Checking
-------------	----------------------------------

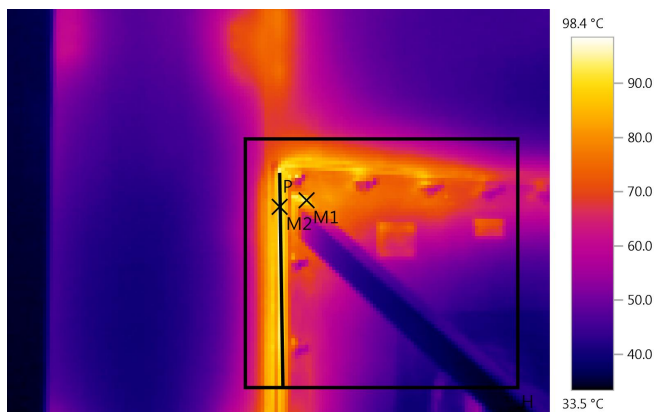
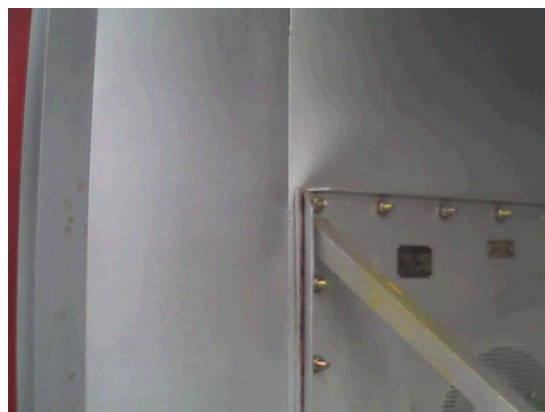
File:
IV_00160.BMT

Measurement Objects	Temp. [°C]	Emiss.	Refl. temp. [°C]	Remarks
Measure point 1	96.6	0.95	20.0	-
Measure point 2	97.6	0.95	20.0	-

Paint Both Furnace Gate, temperature leakage. It is very hazards, kindly check gas kit & gate nut bolts.
